Unplanned initiation Clermont 24th November 2017

Date & Time of Incident:	24 Nov 2017 at 2030 hrs
Location:	Clermont Coal
Incident Summary:	Unplanned initiation of blast hole E2 on pattern P16-158-01T
Persons Injured:	Nil

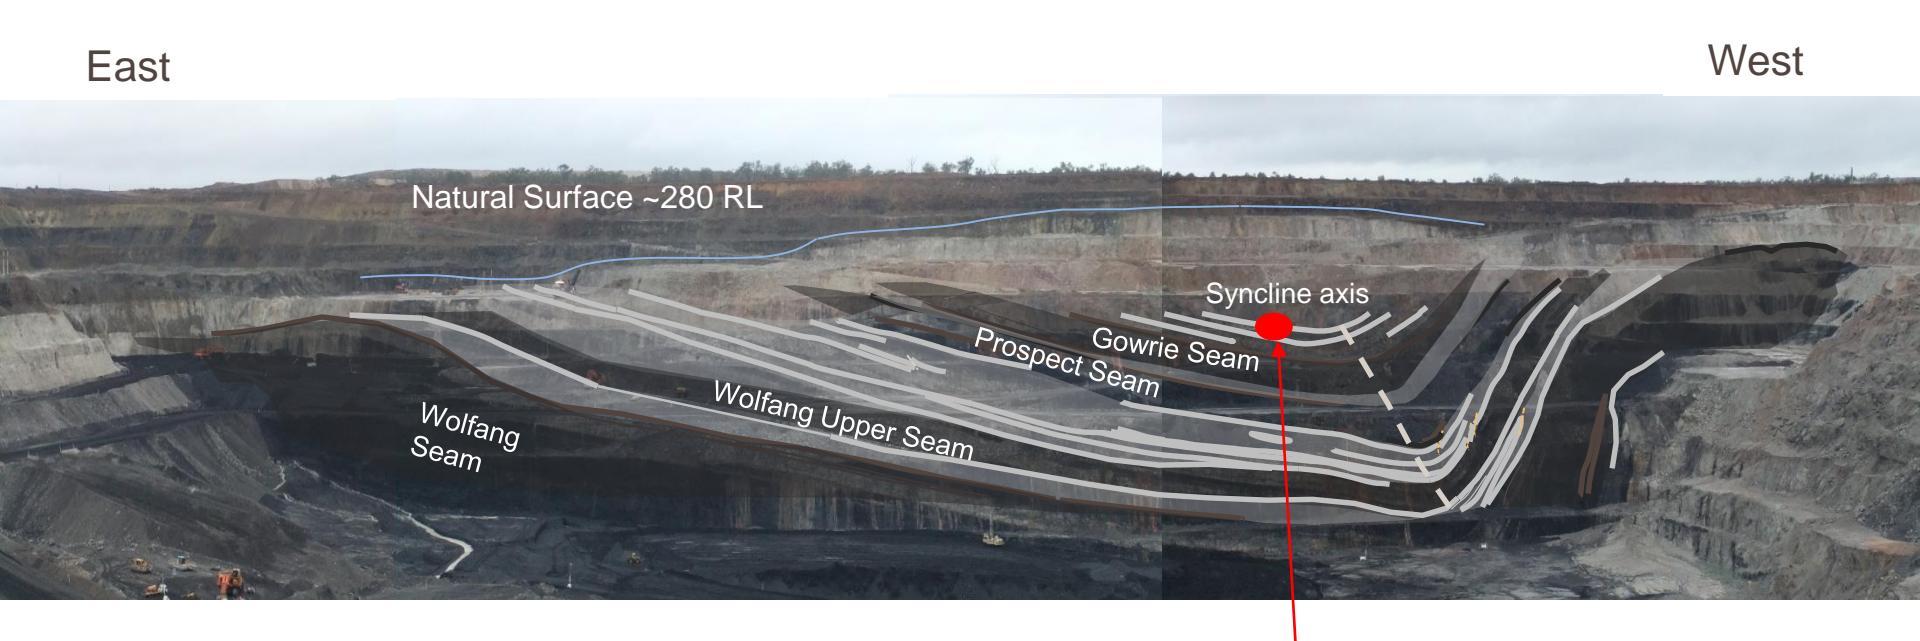
Approximate location of incident

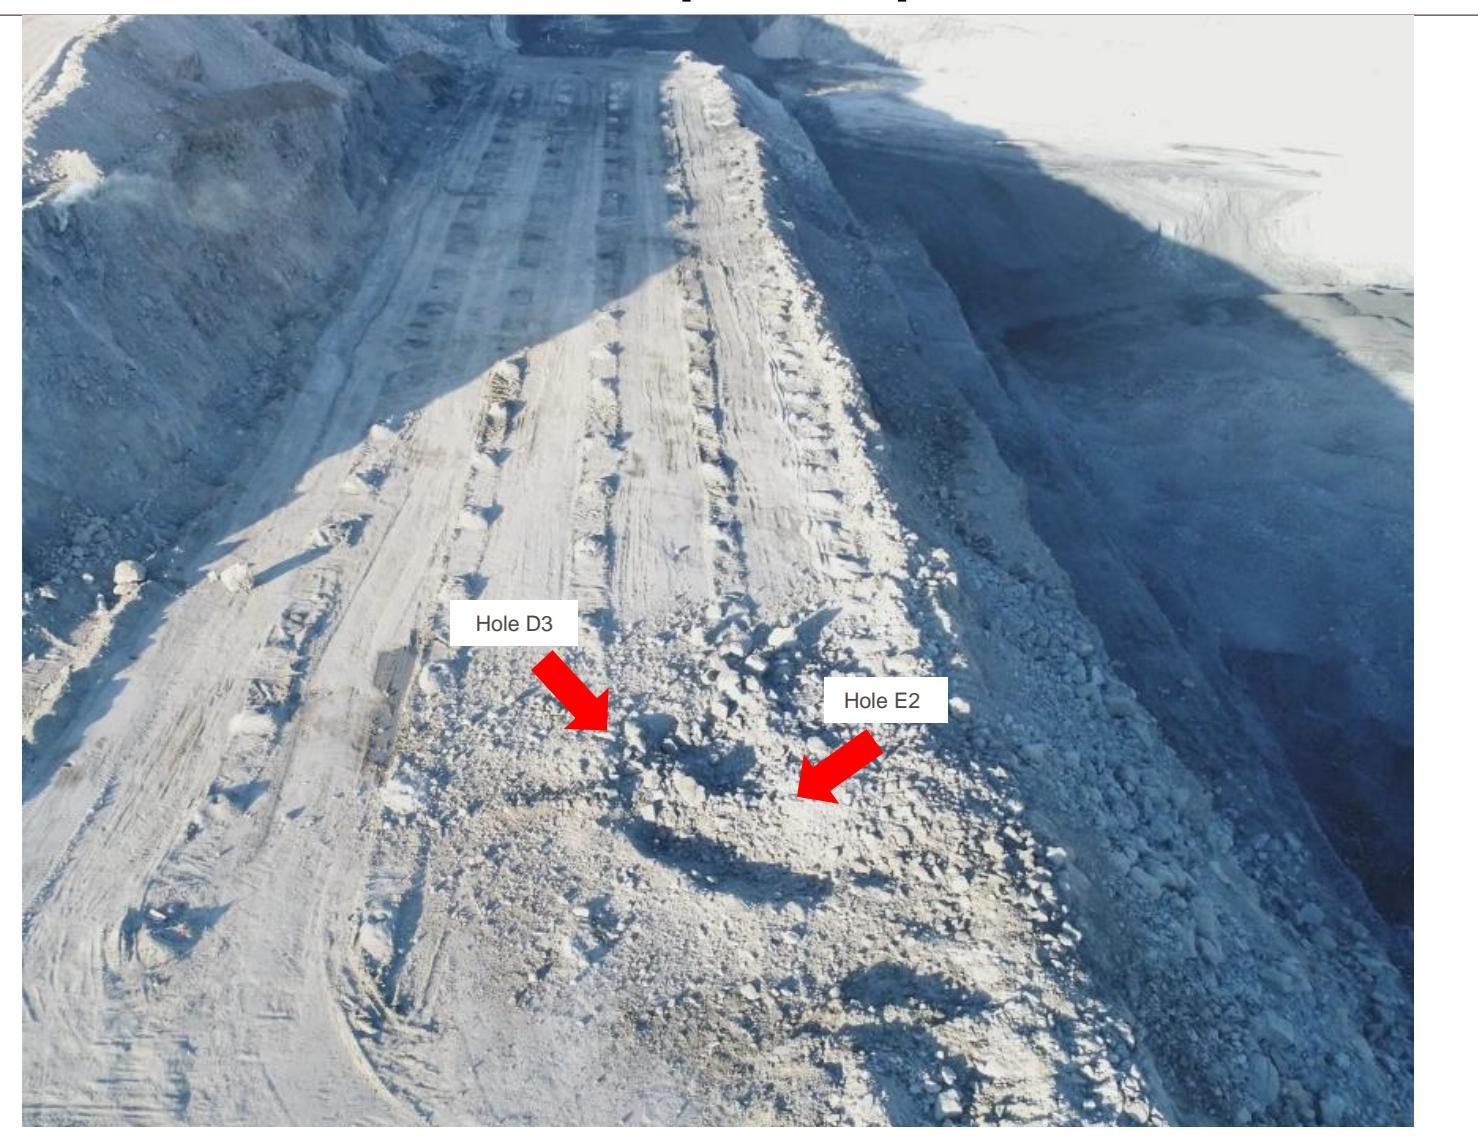
Incident Photo – P16 Blast pattern post incident

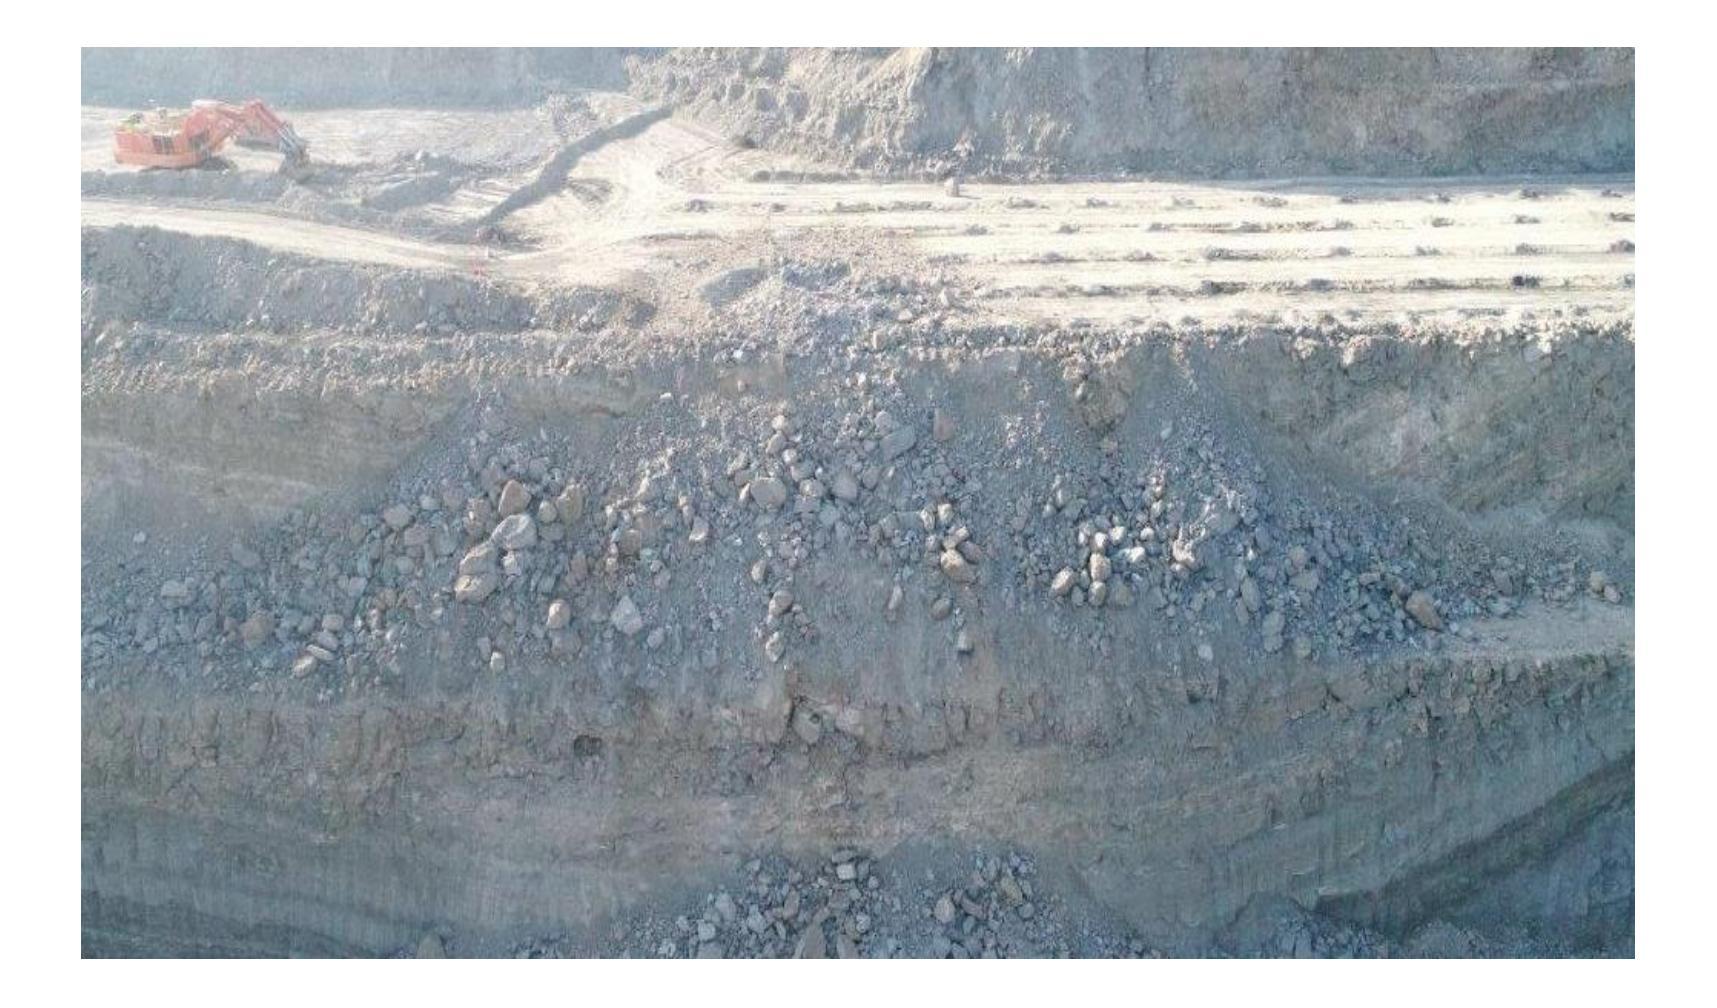
Incident Photo – P16 Blast pattern post incident
