Unplanned initiation Clermont 24th November 2017

Date & Time of Incident:	24 Nov 2017 at 2030 hrs
Location:	Clermont Coal
Incident Summary:	Unplanned initiation of blast hole E2 on pattern P16-158-01T
Persons Injured:	Nil

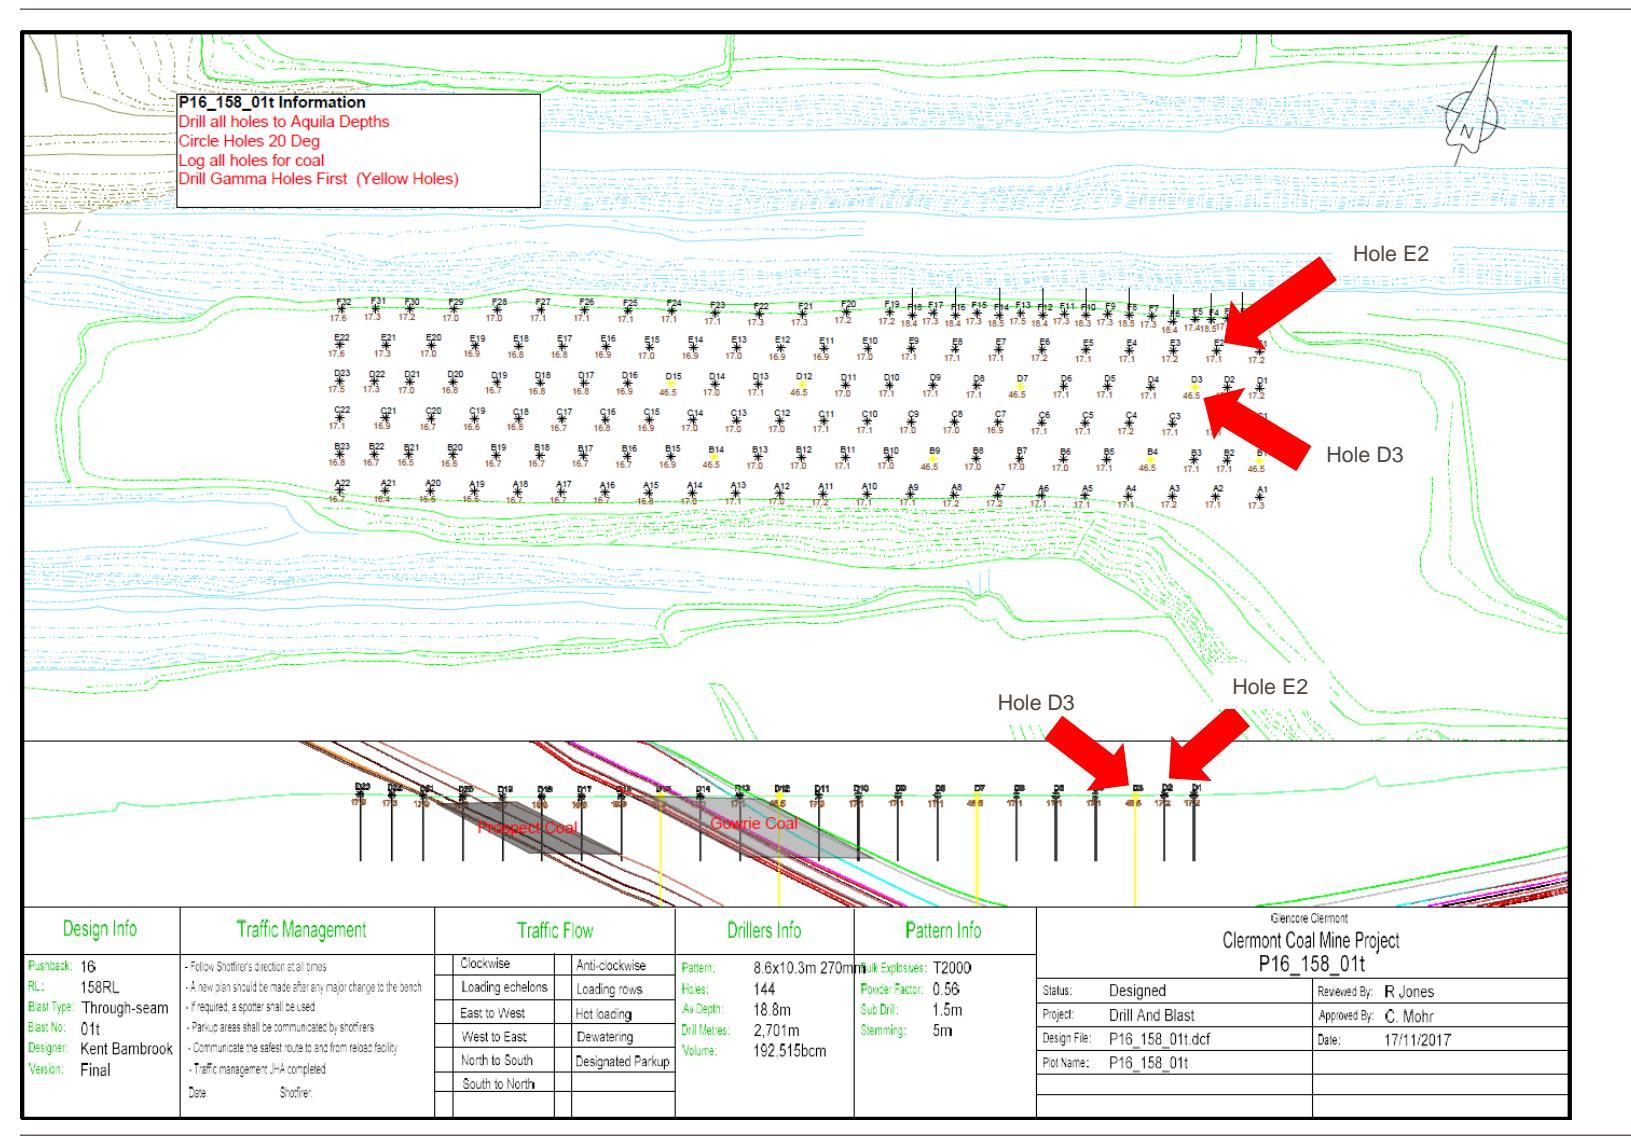
Incident Location

- On the 24th November 2017 at 8:30pm an unplanned initiation of blast hole No. E2 on pattern P16-158-01T occurred.
- There was no work being undertaken on the blast pattern at the time of the incident, and the initiation was not witnessed by any individuals.
- The exact timing of the initiation is known as it registered on the sites blast noise and vibration monitoring system.
- The incident was discovered during a routine inspection of the area by three supervisors at approximately 11:15pm that evening.
- Emergency procedures were enacted and the investigation team mobilised.
