RISK MANAGEMENT AT MASAI QUARRY

November 2016

Martin Adam Manager Global Technical Excellence

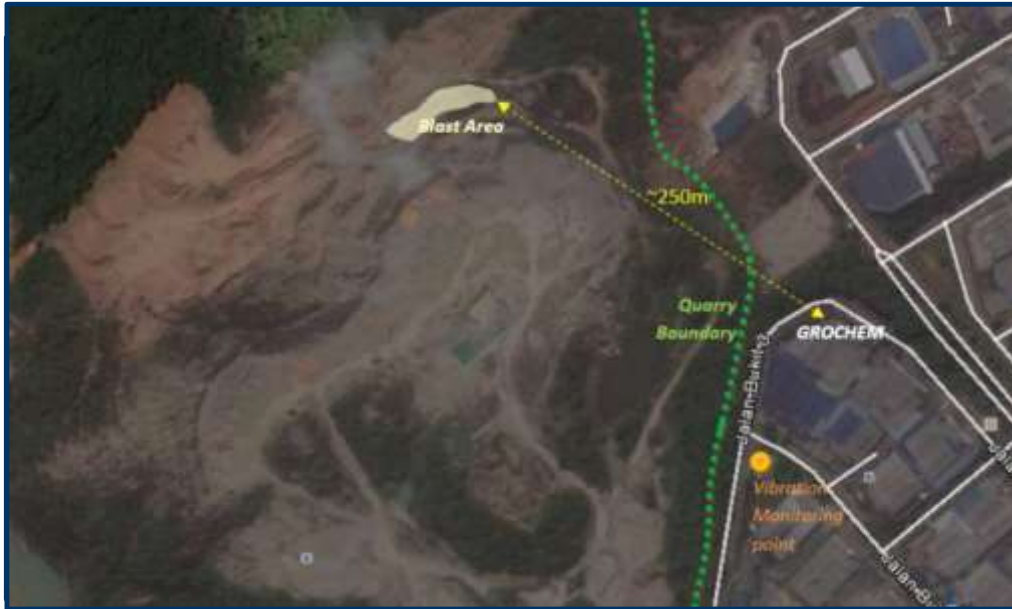
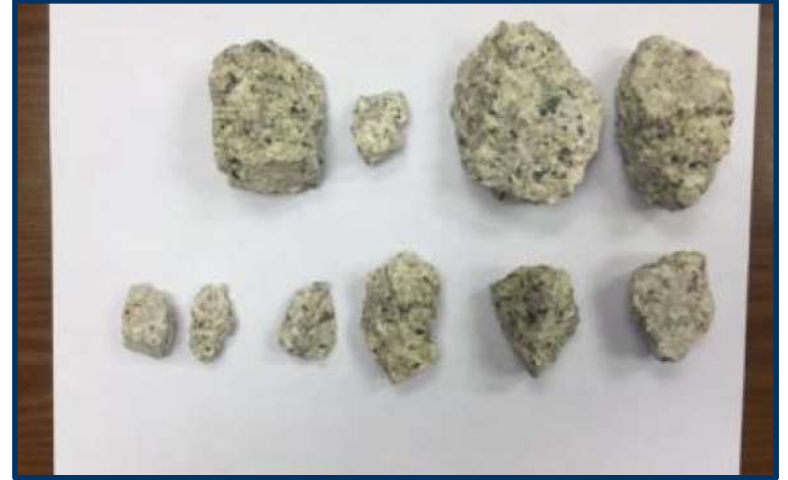
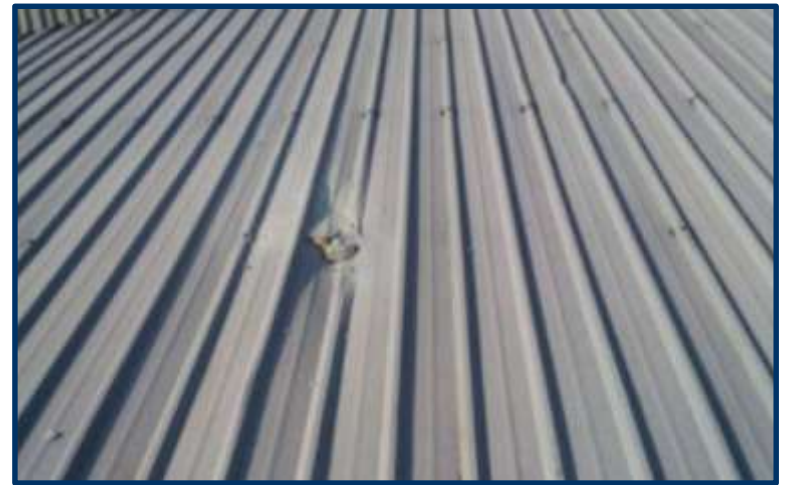
FLYROCK RISK ASSESSMENT

BTQ Masai Blasting Risk Assessment (Flyrock)		Value	Weighting	Score
Blast Number				
Date of Assessment				
Conditions	Wet Holes (1) = Wet holes expected	1	8.0%	8%
	Geology (1) = Transitional Rock	0	8.0%	0%
	Damage (1) = Visible prior blast damage	0	8.0%	0%
Face	Free face (1) = no free face	0	8.0%	0%
	Face direction (1) = South or East, (0) = North or West	1	8.0%	8%
	Bench Ht (value in metres)	15	1.0%	15%
Trajectory	Bench Elevation (m)	20	0.2%	4%
	Distance from Grochem (m)	200	5.0%	25%
Risk Factor				60%

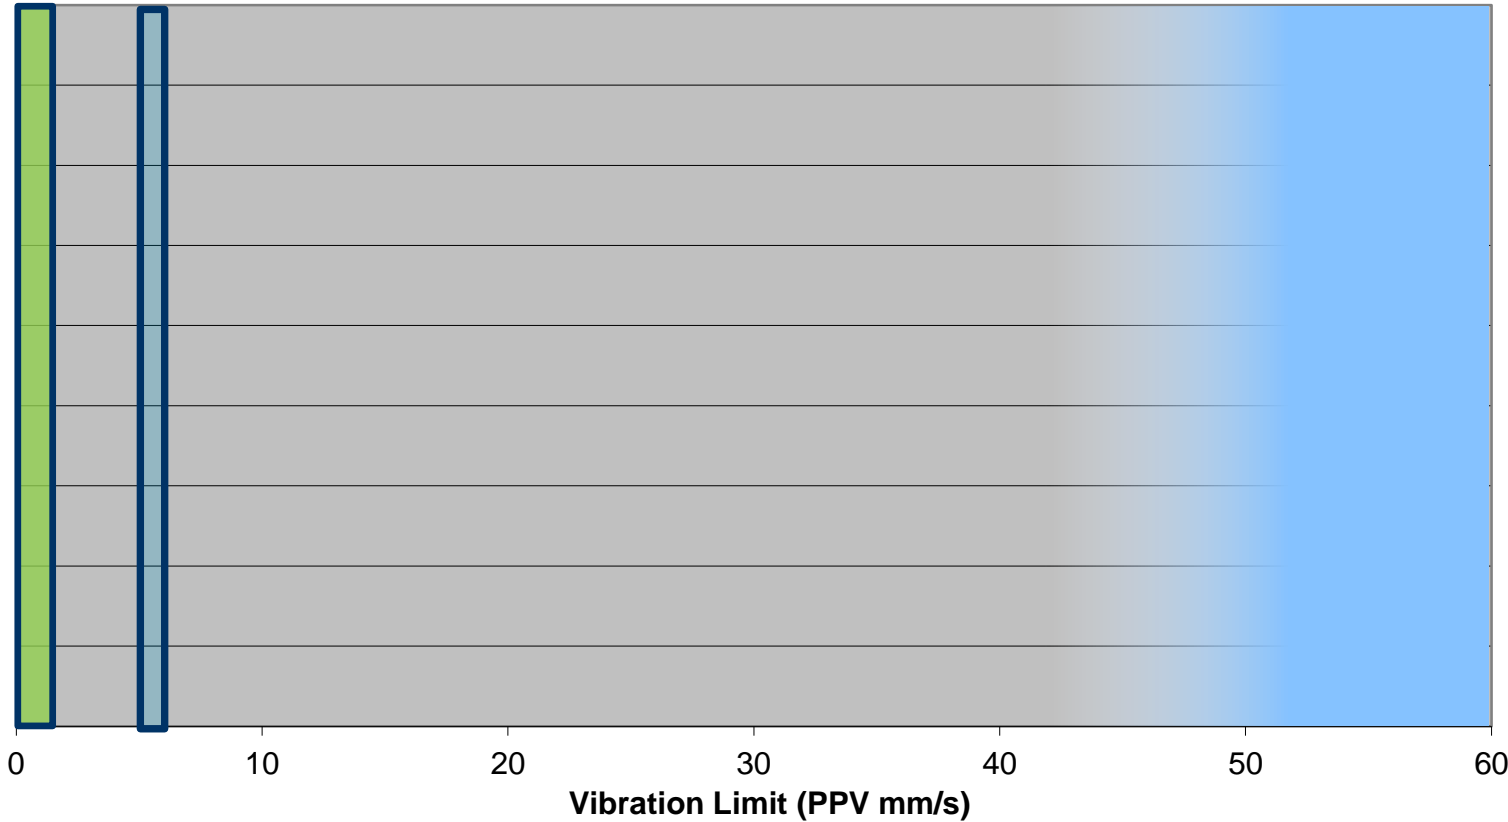
WHAT IS THE BEST VIBRATION LIMIT?

Range for “lowest net cost to community”

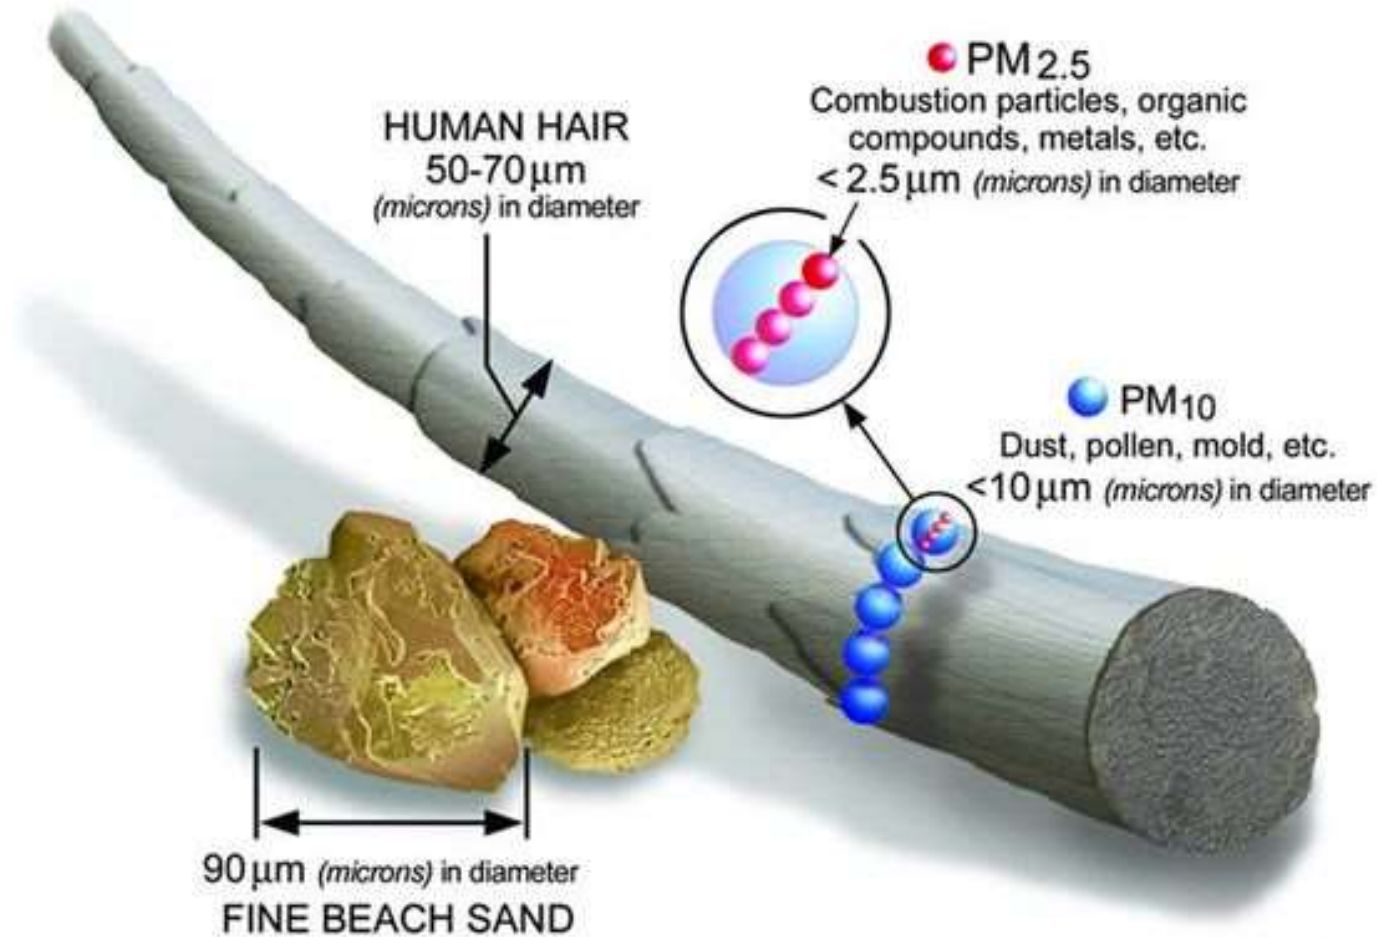
LESS THAN A SMOKE PARTICLE

NCVIB – VIBRATION RESULTS ONLINE

Measurement Point#	Placement	Date	Value
01 - V	Geocoin	09/10/2016 17:38	5.5 mm/s
01 - L	Geocoin	09/10/2016 17:38	1.00 mm/s
01 - T	Geocoin	09/10/2016 17:38	2.35 mm/s
02 - V	Geocoin	09/10/2016 17:38	2.40 mm/s
02 - L	Geocoin	09/10/2016 17:38	0.80 mm/s
02 - T	Geocoin	09/10/2016 17:38	0.95 mm/s
03 - Ext	Geocoin Extensometer		-

03 - Ext Geocoin Extensometer [ms] [Crack width]

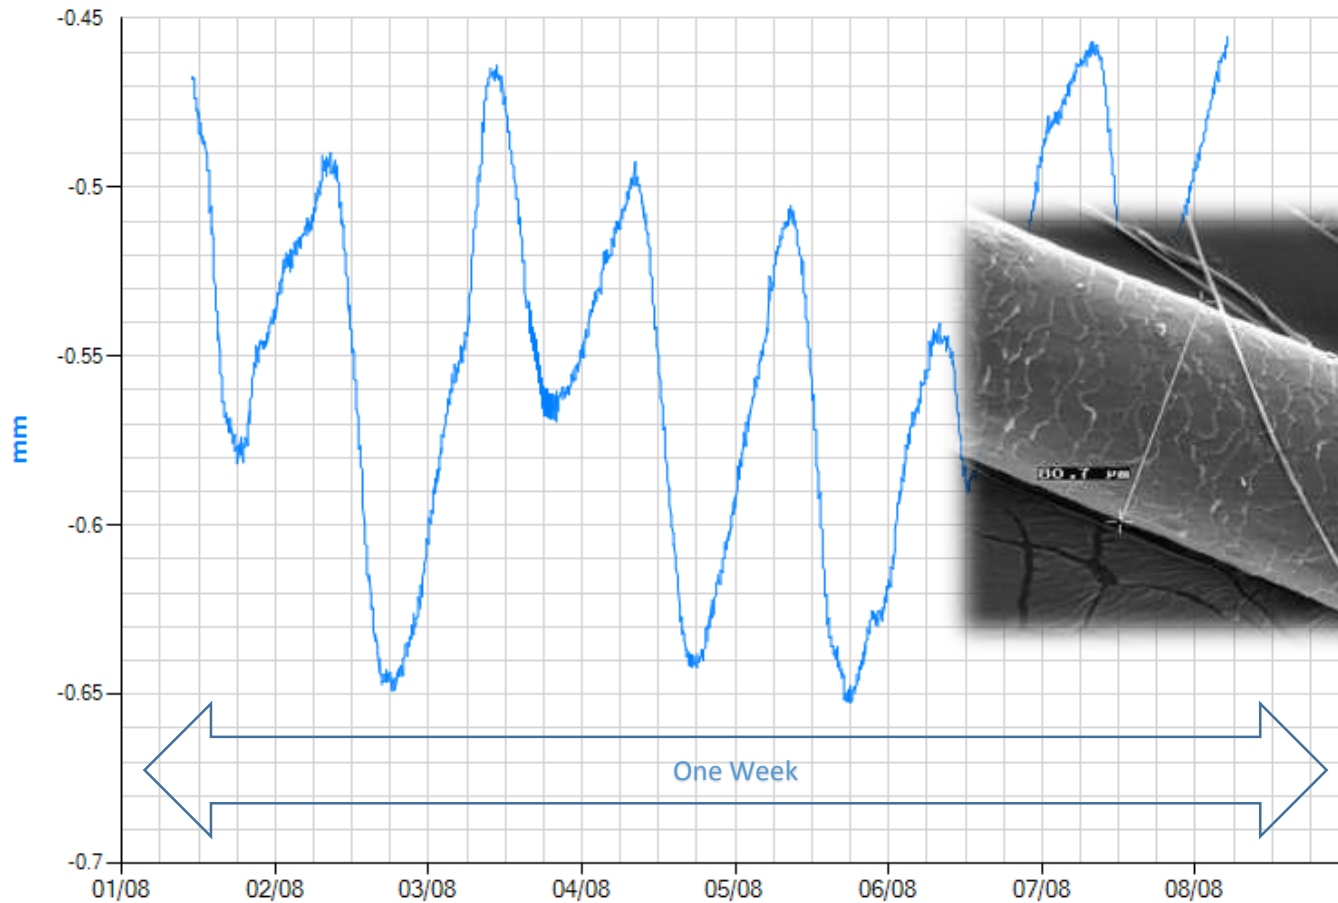
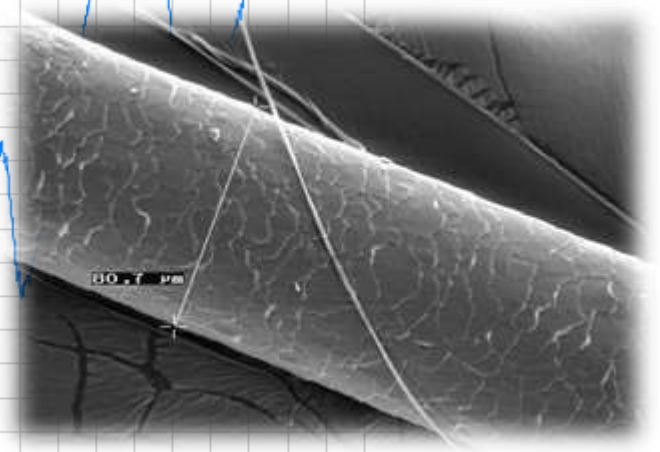
EXTENSOMETER RESULTS

— 03 - Ext Extensometer [mm] Crack width

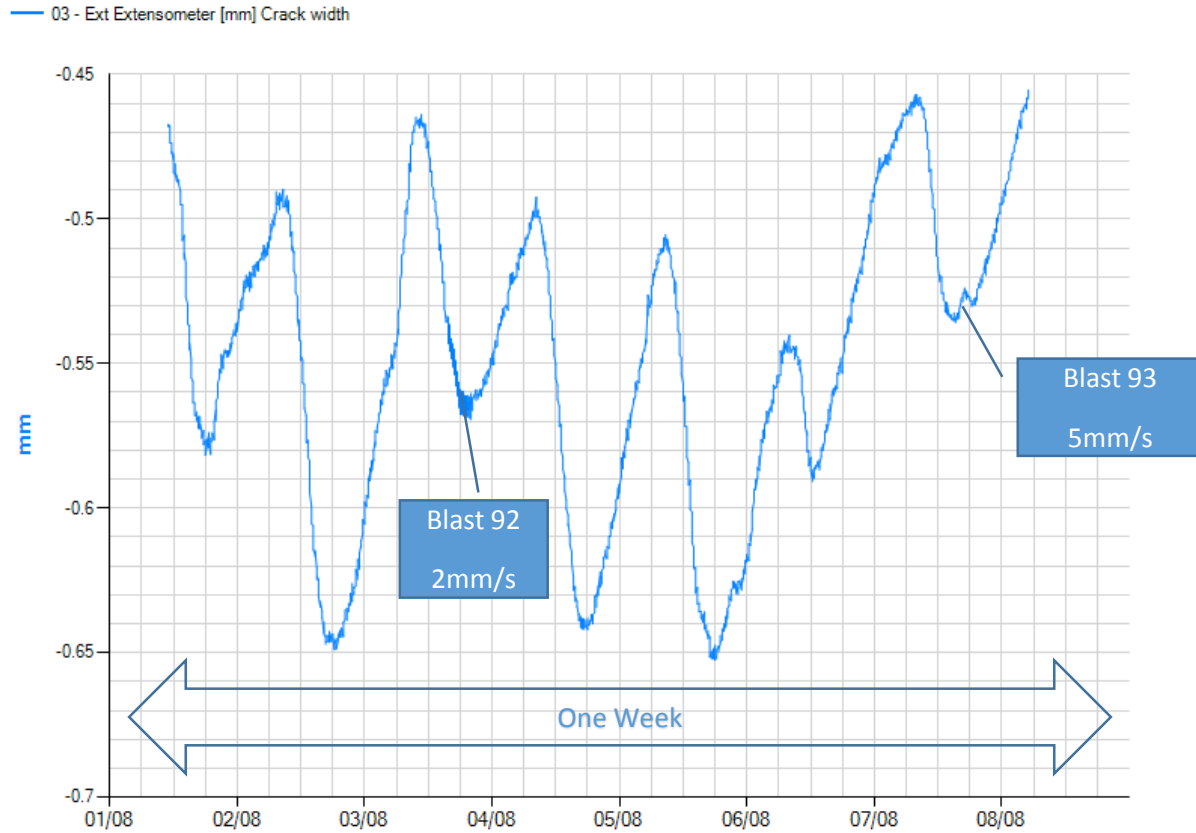
EXTENSOMETER RESULTS

From 14/08/2016 00:00 To: 14/08/2016 23:59

03 - Ext Extensometer [mm] Crack width

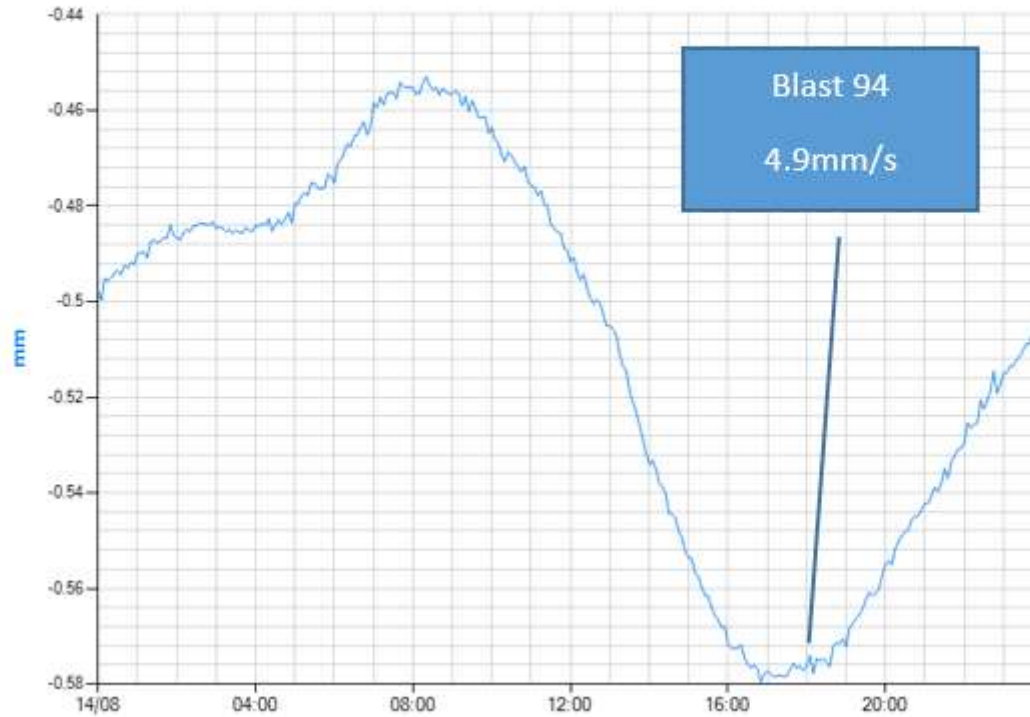
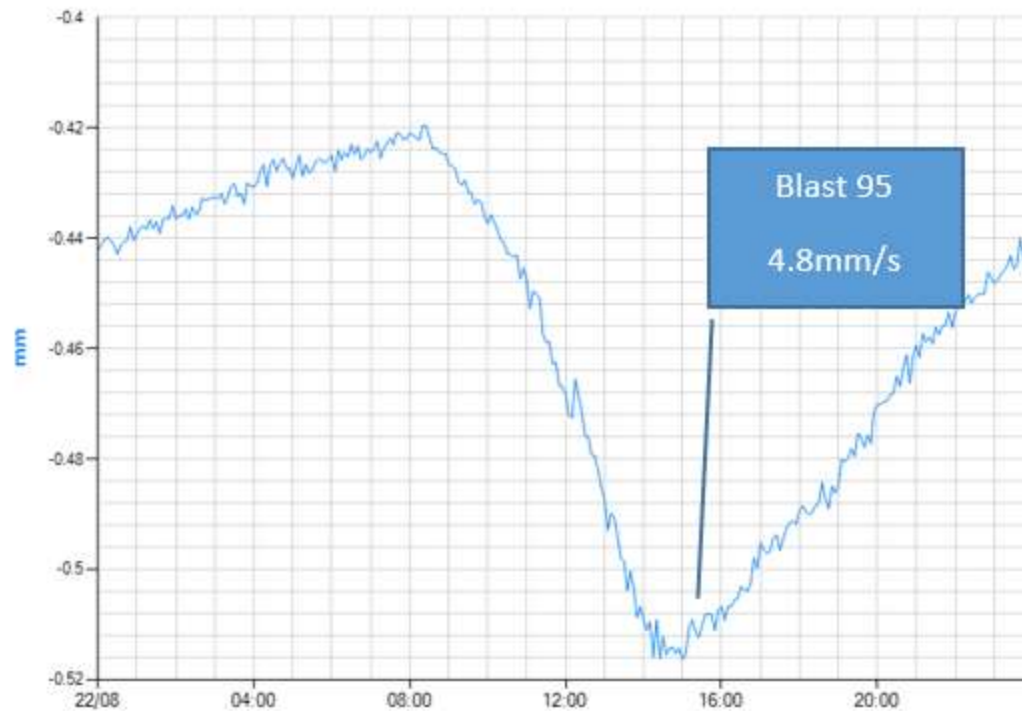
< 1 Day

From 22/08/2016 00:00 To: 22/08/2016 23:59

03 - Ext Extensometer [mm] Crack width

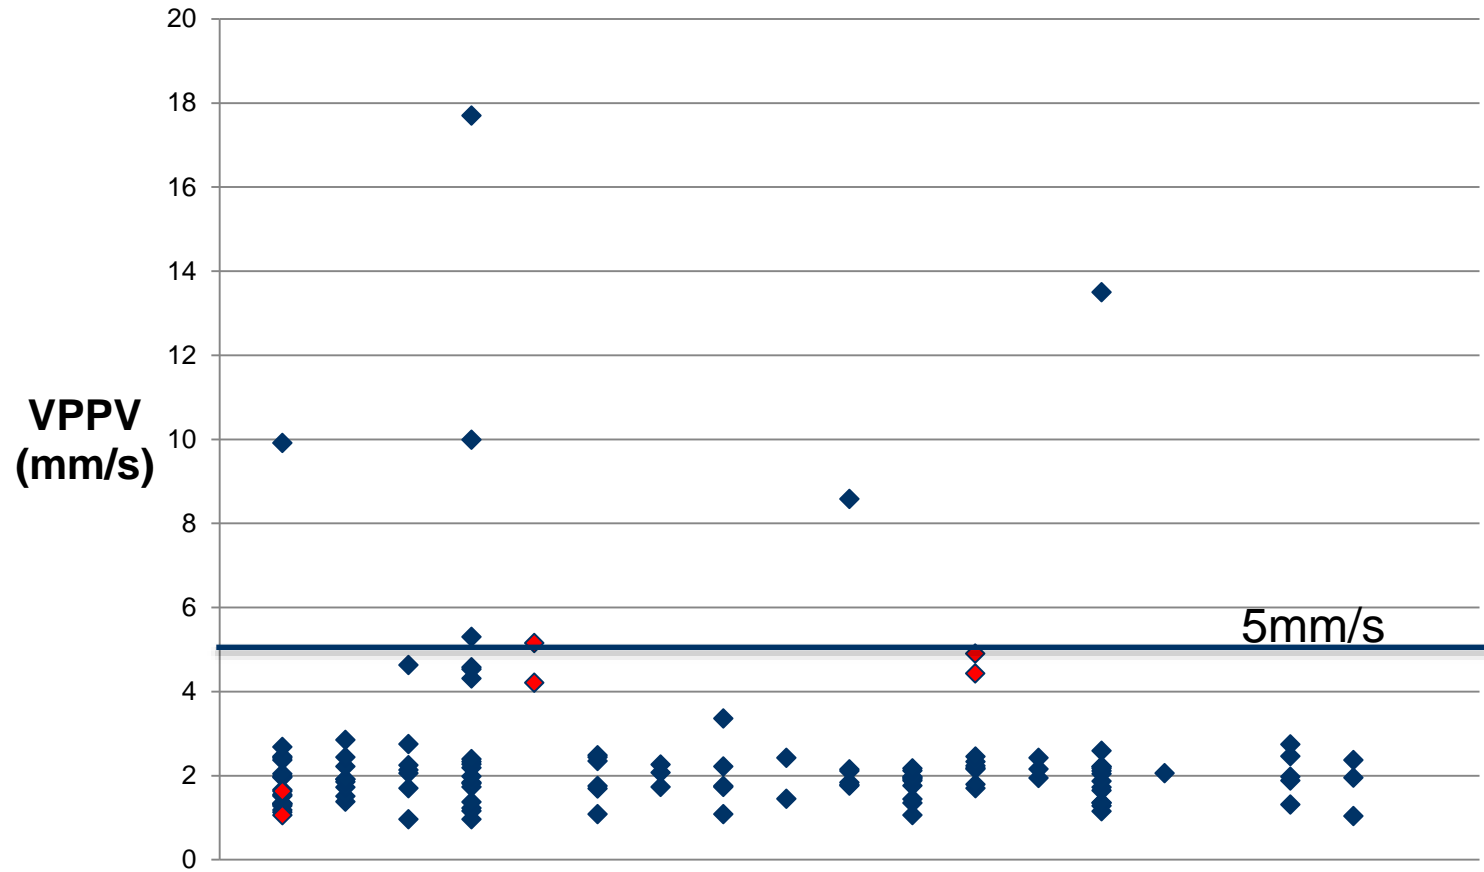
EVENTS THAT WEREN'T BLASTS

All Triggers 3 August - 20 August
